NPIC/R-127/63
July 1963

PHOTOGRAPHIC INTERPRETATION REPORT

COMPARATIVE ANALYSIS
KERCH/BAGEROVO AIRFIELD, USSR

NATIONAL PHOTOGRAPHIC INTERPRETATION CENTER

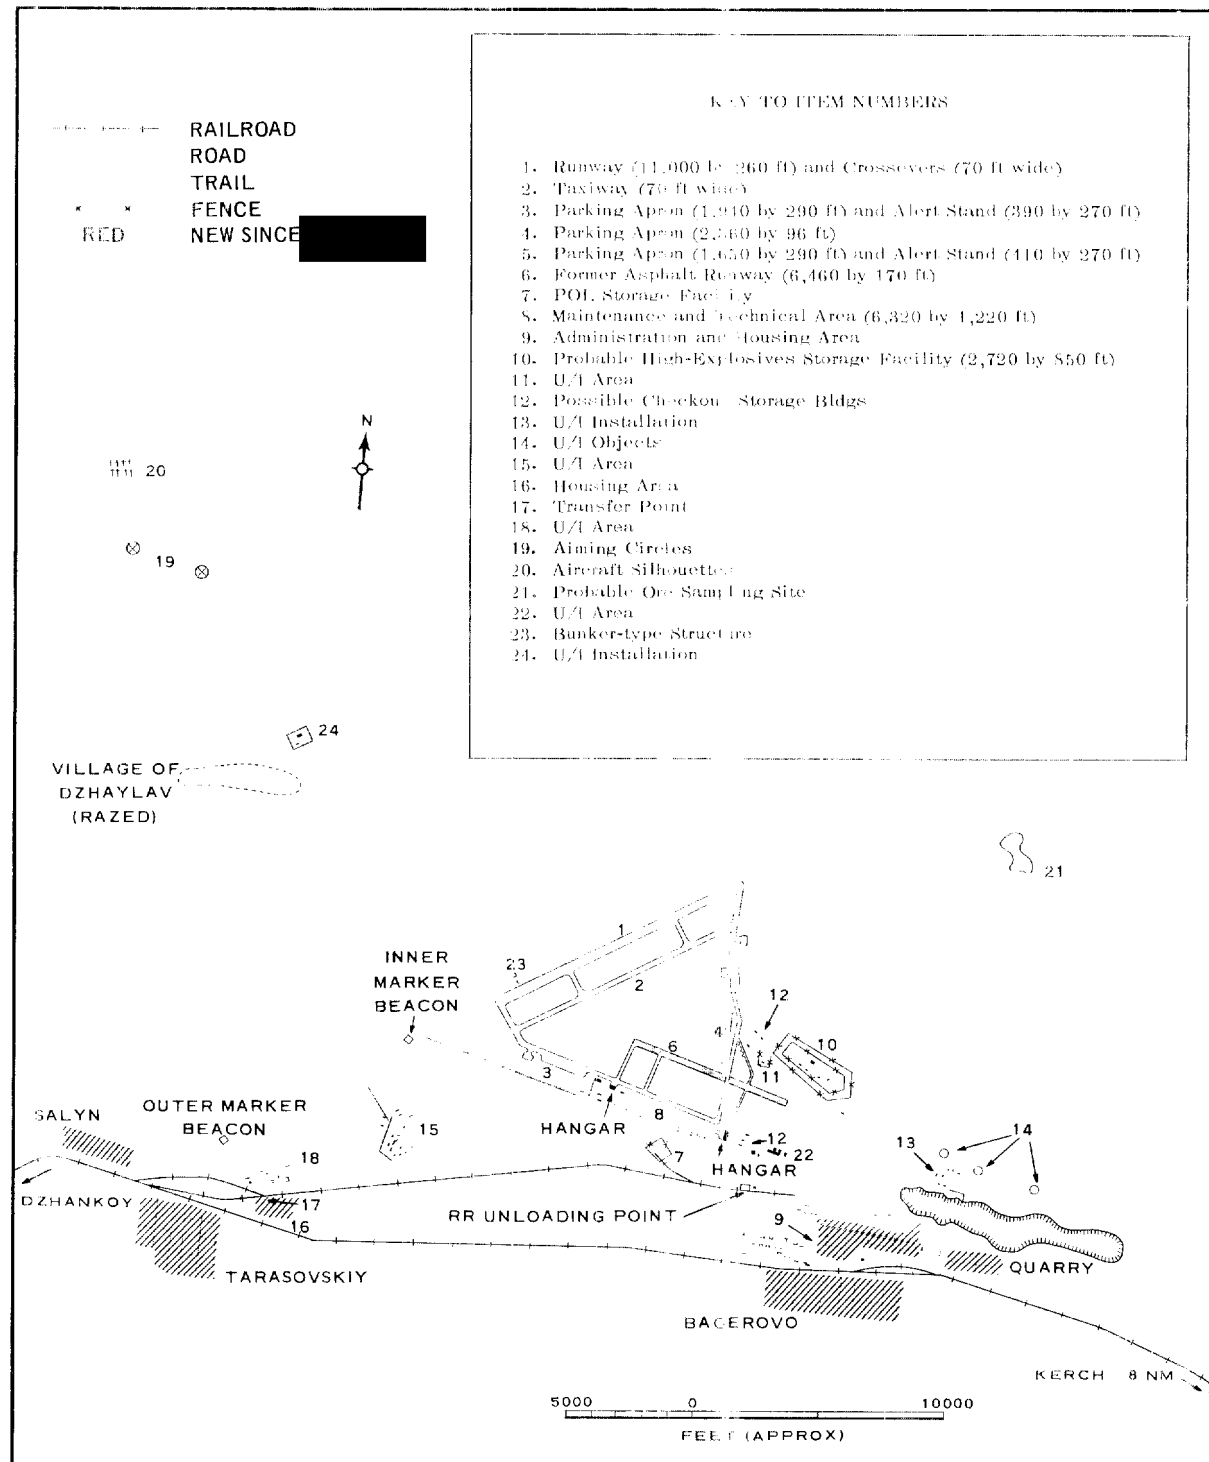
FIGURE 2. KERCH/BAGEROVO AIRFIELD.

rebuilt since [REDACTED] and encompasses an area of approximately 6 by 3.5 nm. It consists of an 11,000 by 260-foot northeast/southwest concrete runway, a triangular taxiway system, a maintenance and technical area, storage facilities, and two administration and housing areas (Figures 2 and 3). In addition to an intricate road system, the field is served by a spur from the Kerch-Dzhankoy rail line which passes the southern side of the field.

No significant changes are visible in the permanent facilities such as the runways, taxiways, and parking facilities since [REDACTED] 25X1D The [REDACTED] 25X1D photography reveals that aircraft are parked on the west (item 3)* and northeastern (item 5) parking aprons. Although the scale of this photography precludes identification and an accurate count of the aircraft, at least three large aircraft are observed on the west parking apron.

The two administration and housing areas are located just north of the town of Bagerovo and east of Tarasovskiy respectively. The first and larger of the two areas (item 9) has had an increase in the number of housing facilities and barracks, and at least one large administration-type building has been added since [REDACTED] 25X1D No significant construction has taken place since that time at the smaller of the two housing areas (item 16).

The maintenance and technical area (item 8), located south of the east/west taxiway, contains two large hangars, numerous shops, and laboratory/engineering-type buildings. No significant changes have occurred in this area since [REDACTED] 25X1D A new concrete road connects the area with the airfield service road which extends to Tarasovskiy.

25X1D
A large, secured, probable high-explosives (HE) storage facility (item 10) is located east of the central parking apron. The facility contains three large and two small revetted storage buildings. No significant change has occurred at the site since [REDACTED]. A probable revetted building is visible just southeast of this facility, and an unidentified secured area (item 11) situated west of the probable HE storage facility contains several new buildings.

25X1D
The [REDACTED] photography reveals three small groups of possible checkout or storage buildings (item 12) located east of the north/south taxiway. The group formerly located near the north end of the north/south taxiway is no longer visible on the [REDACTED] photography. The remaining two groups show no significant change. The road-served, secured, bunker-type structure (item 23) just north of the southwest end of the runway is barely discernible on the [REDACTED] photography. Two small structures have

been constructed immediately south of the bunker-type structure. An unidentified area (item 22) east of the maintenance and technical area contains one new building. The function of this area cannot be determined. The only other secured storage area at the airfield is the POL storage facility (item 7), which is located south of the maintenance and technical area and which shows no change since [REDACTED]

[REDACTED] The quarry (Figure 2) located east of the airfield probably provides the field with materials to be used in new construction. A previously observed unidentified installation (item 13) located immediately north of the quarry contains seven buildings. It is connected with the airfield by a road, and it is also connected with the quarry by a new road. [REDACTED]

[REDACTED] Three unidentified objects (item 14) visible on the [REDACTED] photograph are still present on a ridge north of the quarry. The lack of associated support facilities suggests that these objects do not comprise a test facility.

Photography of [REDACTED] shows construction taking place at the site formerly occupied by a state farm (item 15) and at a site just north of the Tarasovskiy housing area (item 18). A new hard-surfaced road now connects the

former state farm with the airfield service road to Tarasovskiy. A new hard-surfaced road has been constructed within the area, and approximately 12 small additional buildings are now present. Poor image quality precludes a detailed description and determination of this site's function. The area north of Tarasovskiy remains generally as observed in [REDACTED]. A warehouse along the rail spur has been dismantled and several new buildings have been erected, but no structures are discernible in the area of the large, rectangular excavation observed in the center of this site in [REDACTED]. The excavation itself is no longer visible, and there are no entrances [REDACTED]

No evidence could be found on the [REDACTED] photograph of an engine test stand or related facilities. Ground scarring 2 nm east-northeast of the field is probably an indication of ore sampling (item 21) rather than of testing.

The bombing range located northwest of the airfield contains two aiming circles (item 19). Although these circles apparently have been reconditioned since [REDACTED] they do not appear to have had much recent use. Eight aircraft silhouettes (item 20) arranged in two rows of four each are located just north of the aiming circles. A third row of silhouettes, as well as several miscellaneous targets observed on the [REDACTED] photograph, are no longer visible. No changes are evident at the unidentified installation (item 24) located on high ground 7,000 feet southeast of the aiming circles. This installation may be an observation site associated with the bombing range.
